APPENDIX A

Photographs

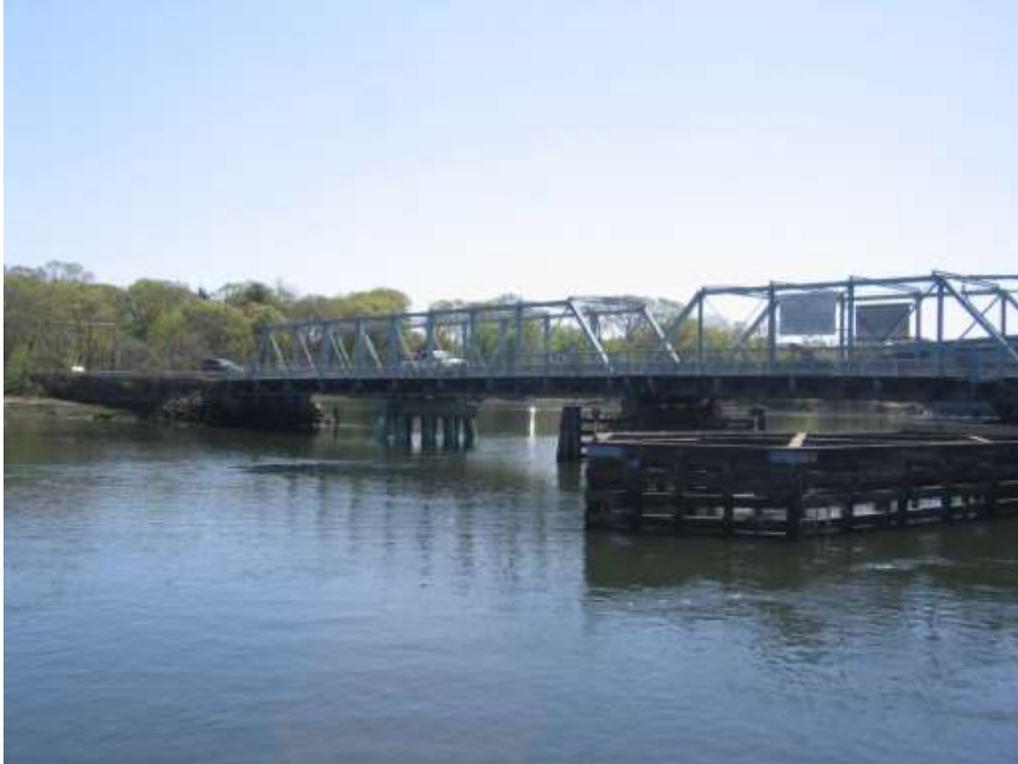
1. Upstream elevation of Bridge No. 01349

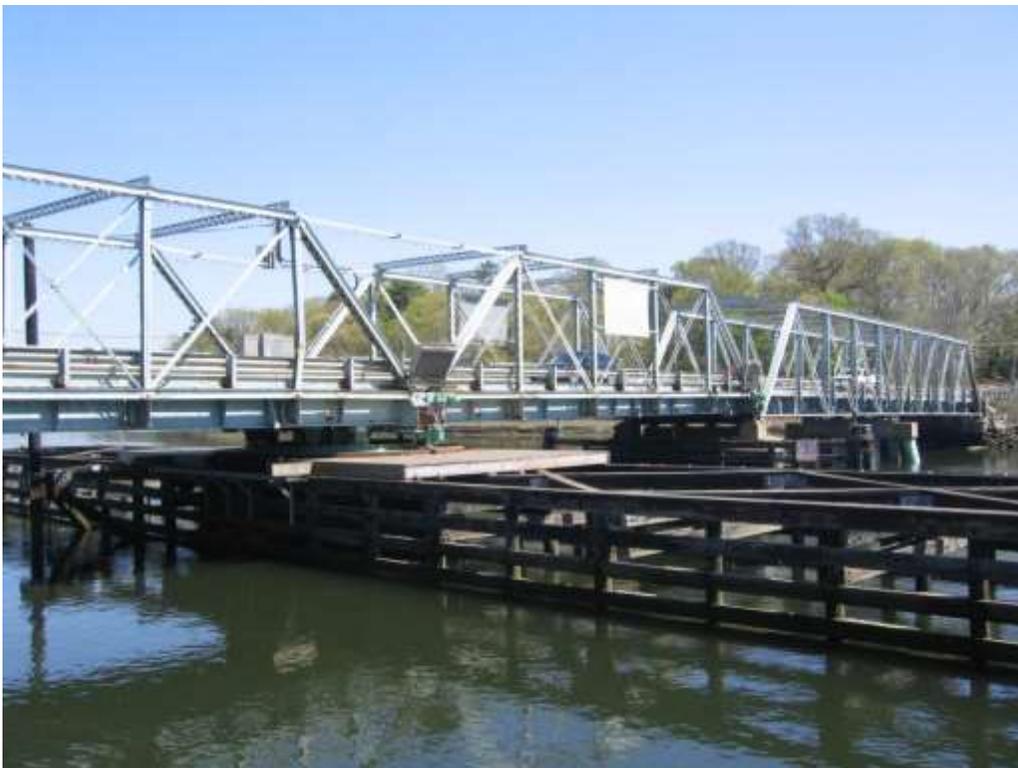
2. Downstream elevation of Bridge No. 01349

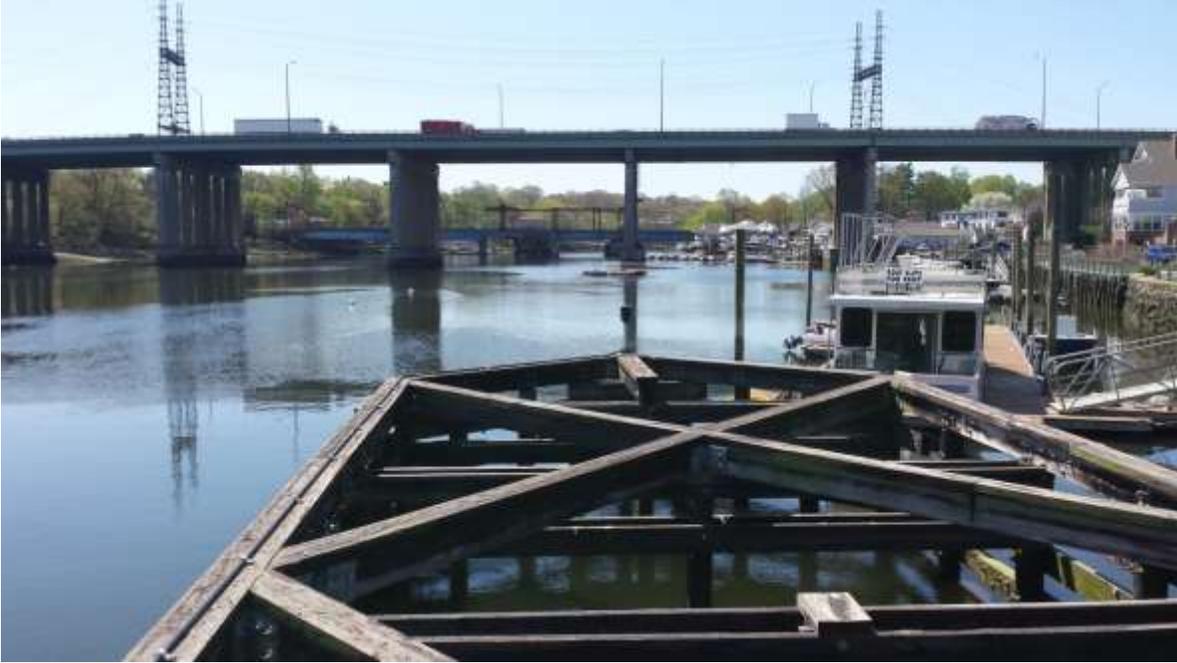
3. Downstream view from Bridge No. 01349

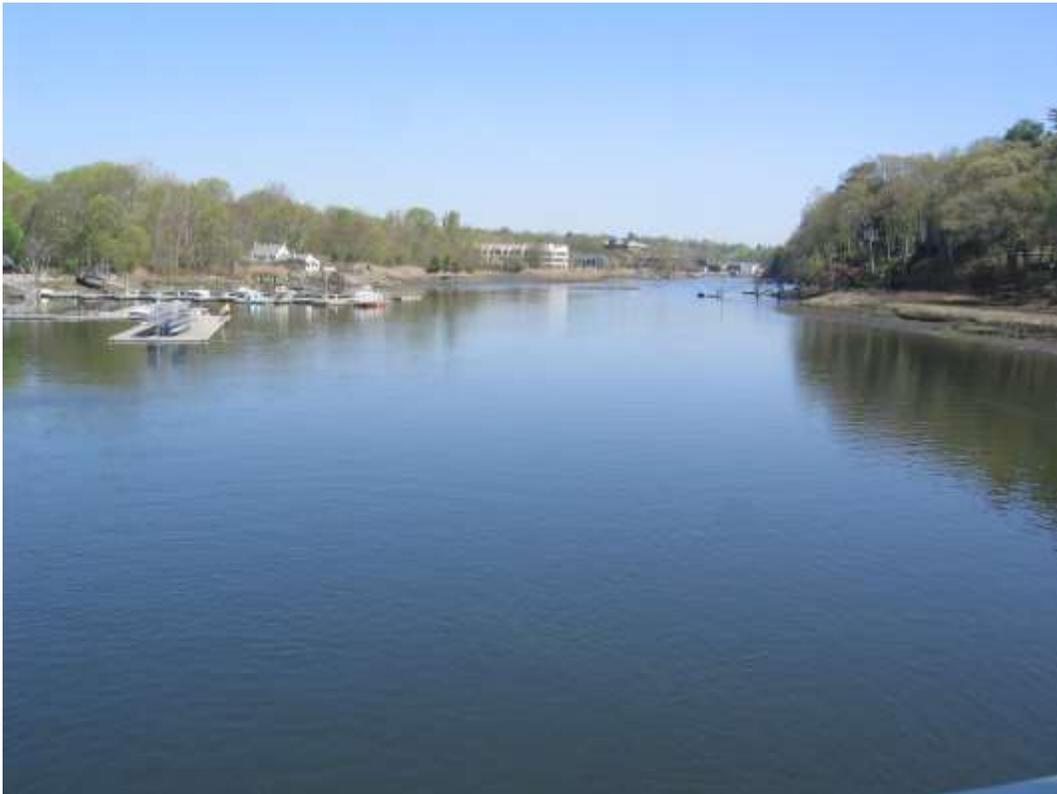
4. Upstream view from Bridge No. 01349

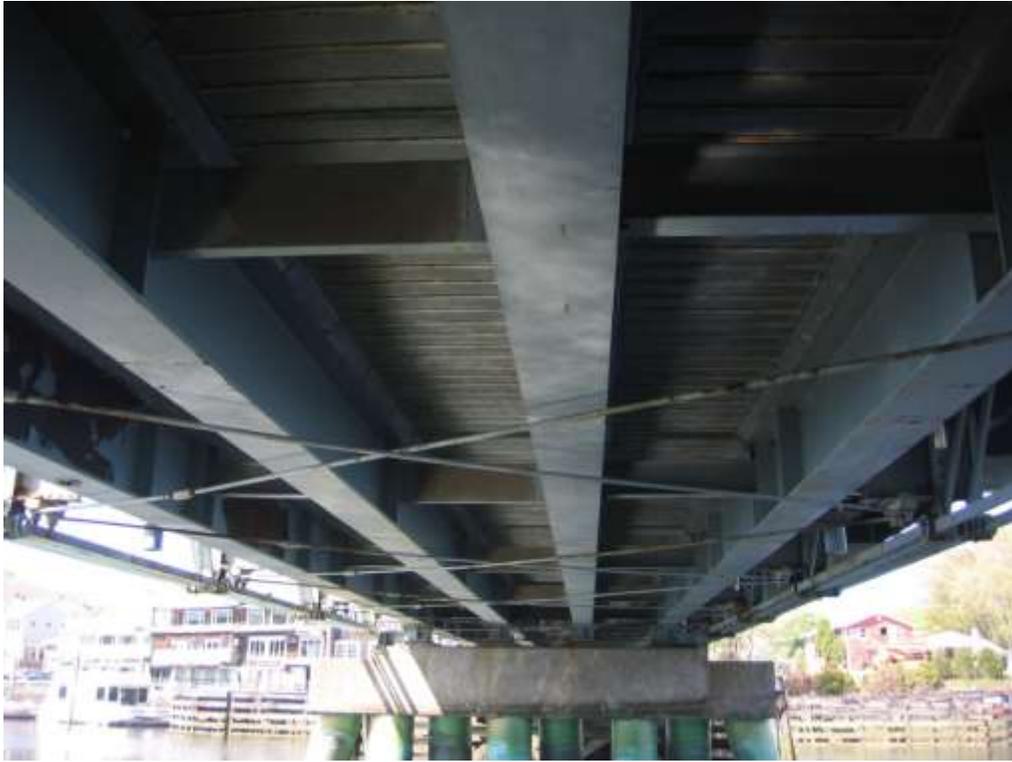
5. Typical condition of underside of deck

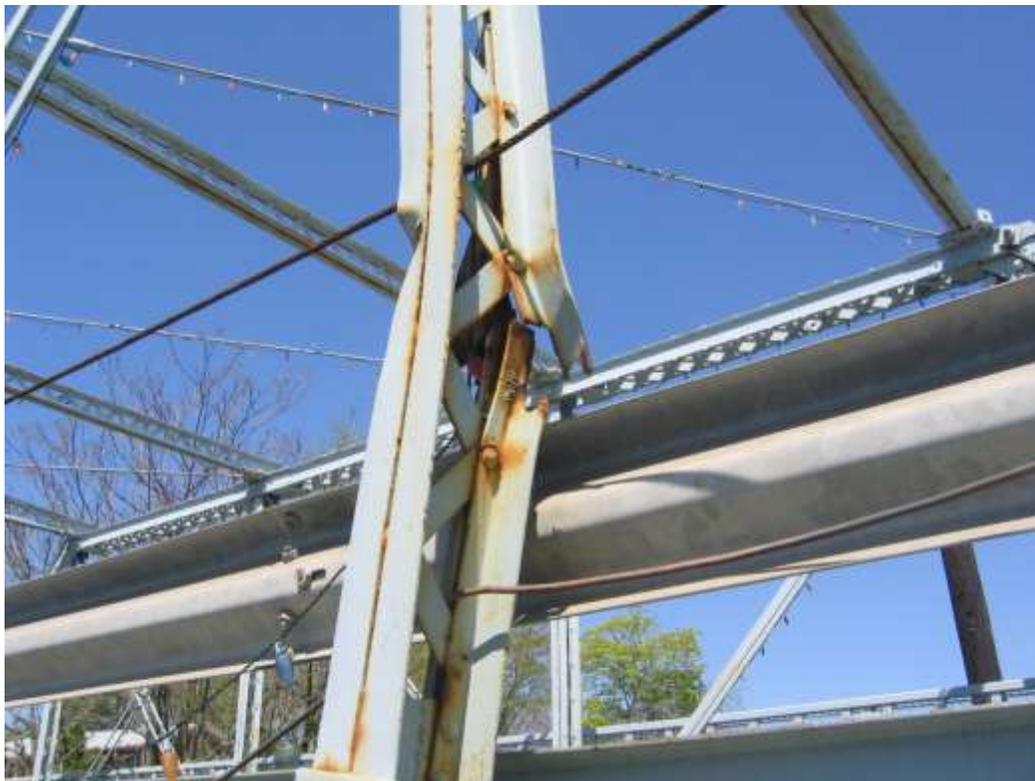
6. Typical condition of the truss

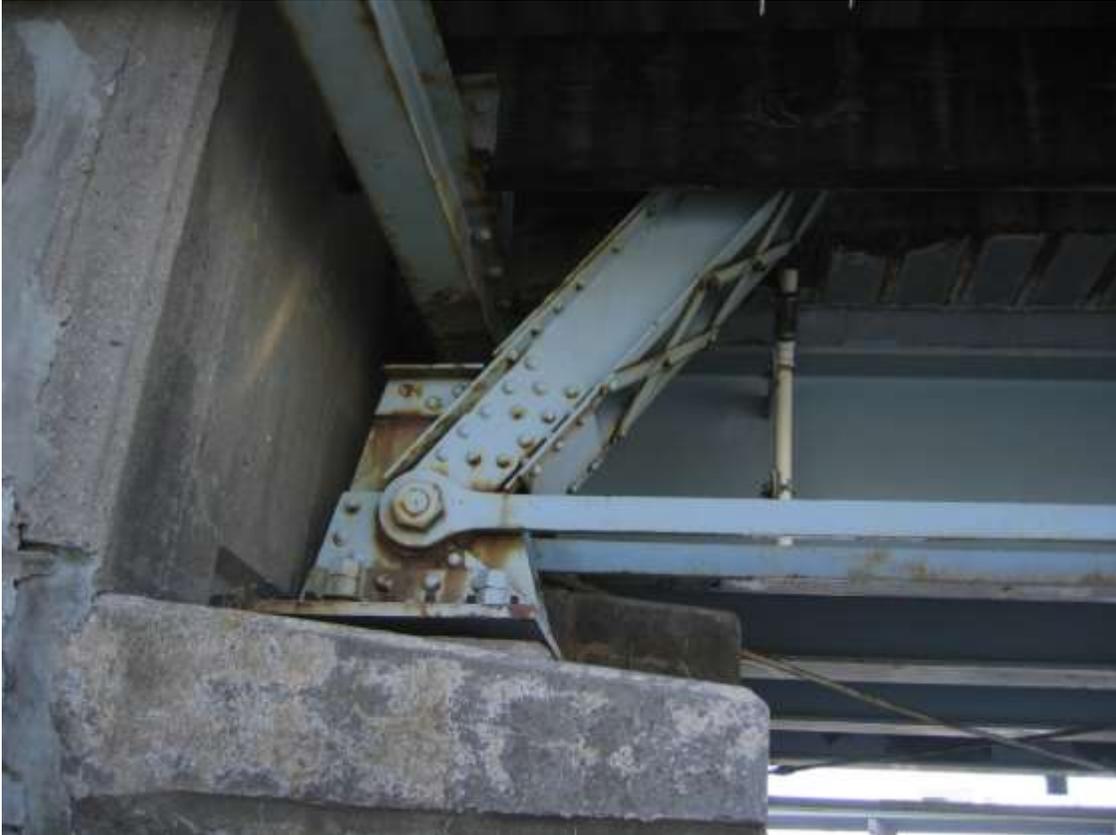
7. Typical condition of truss bearings

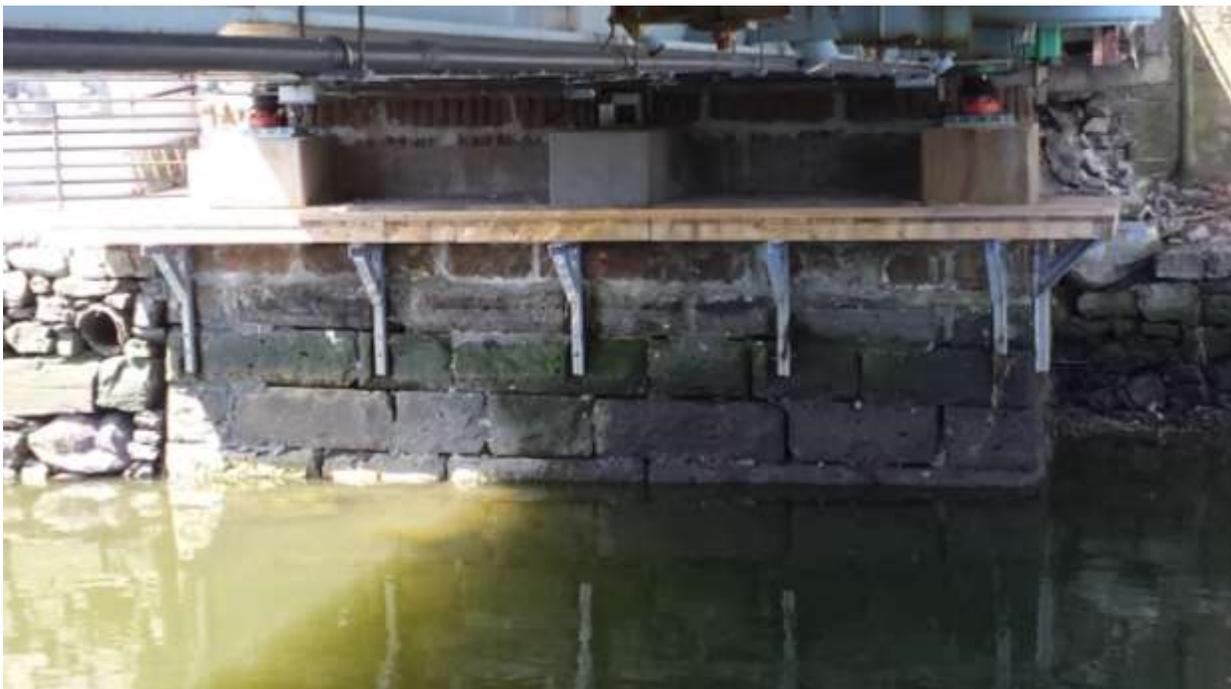
8. Typical condition of stone masonry abutments

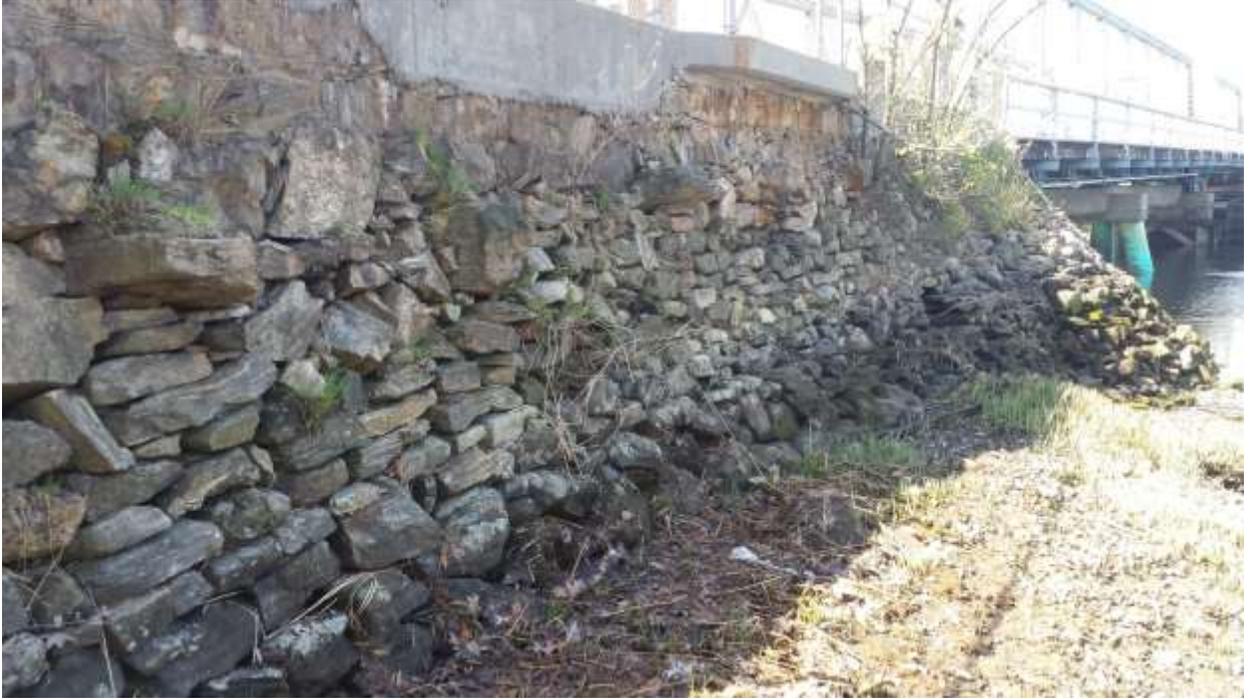
9. Typical condition of stone masonry wingwalls

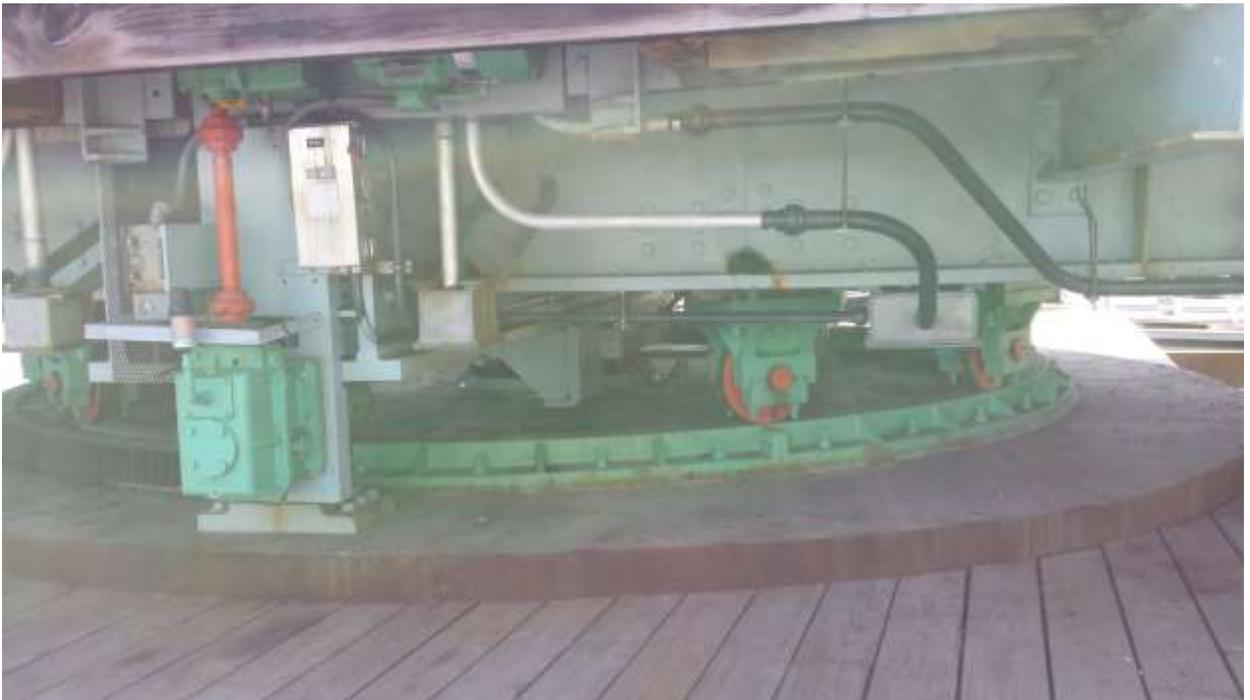
10. Typical condition of swing pier machinery

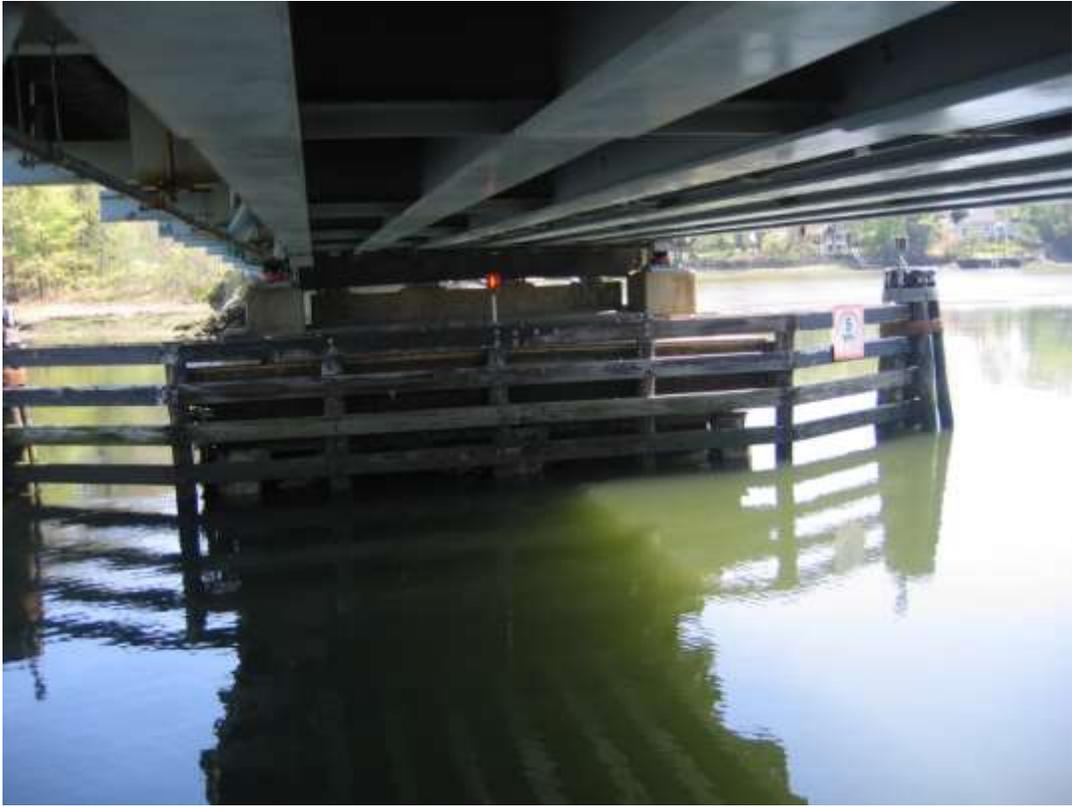
11. Typical condition of pier 2

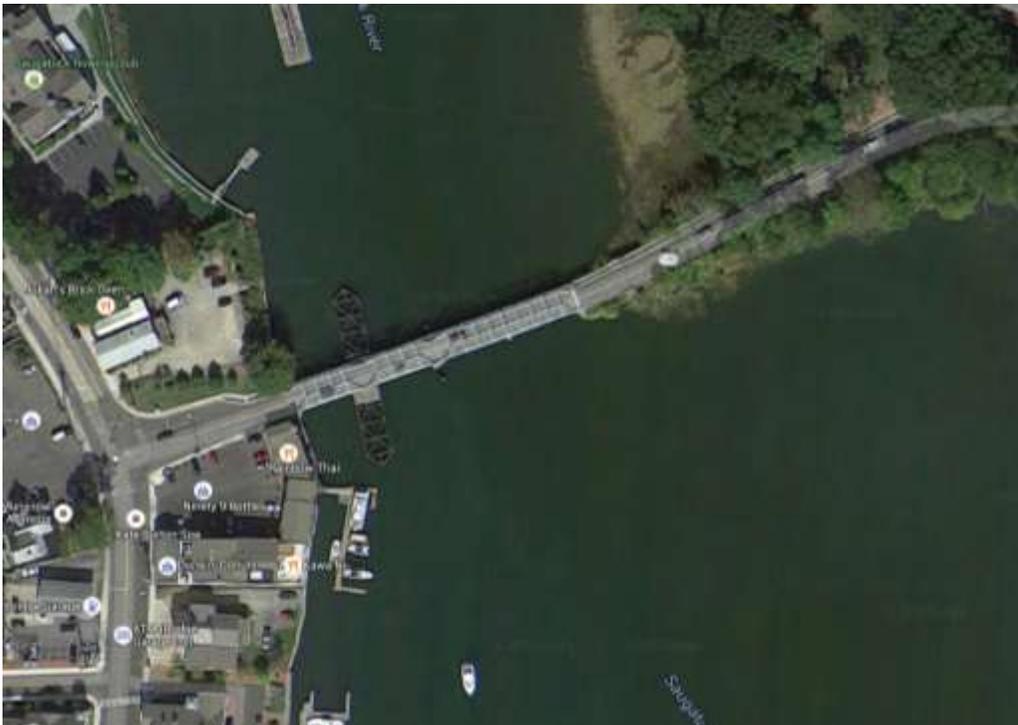
12. Aerial view of Bridge No. 01349

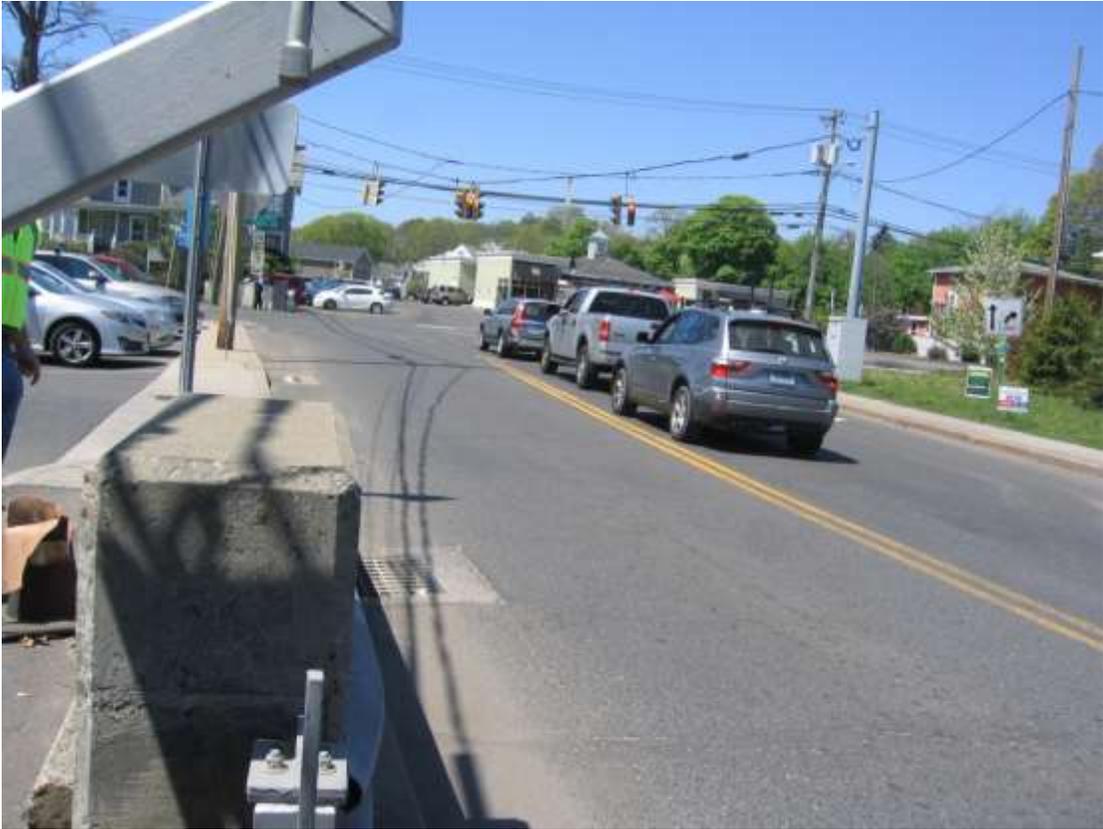
13. Looking west on Route 136

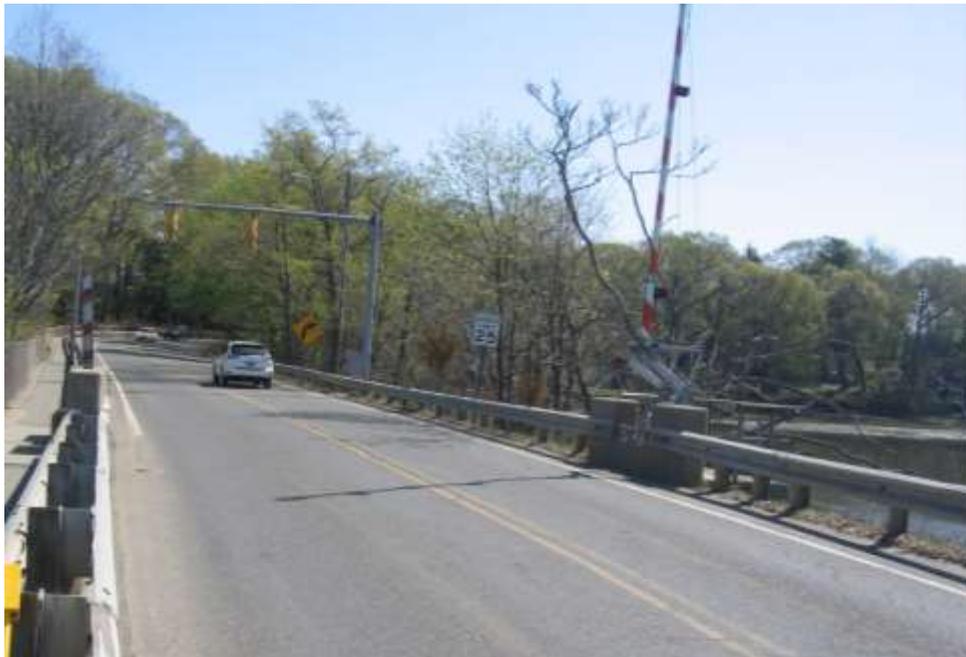
14. Looking east on Route 136
